ANDROSCOGGIN LAKE WATERSHED SURVEY 2022

30 Mile River Watershed Association • P.O. Box 132, Mount Vernon, ME 04352 • www.30mileriver.org

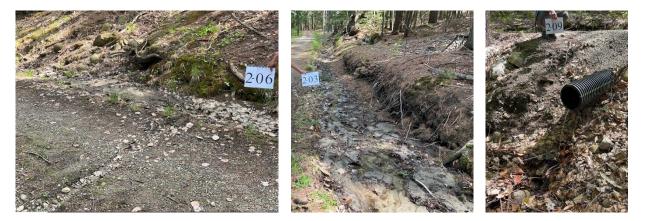
<u>Problems:</u> Unmaintained ditches and undersized culverts resulting in stormwater runoff overtopping road – eroding road surface and shoulder before flowing into lake.

Erosion sites identified on Dole's Beach Road / The Boulevard in Sector 2. Runoff over-topping the road (Site 2-06) and eroding a channel in the road surface, and overwhelmed ditch full of sediment that drains to Androscoggin Lake (Site 2-03), and an unstable culvert outlet (Site 2-09).

<u>Recommendations</u>: Clean out, improve, and stabilize ditches, replace undersized culverts and armor or vegetate inlet/outlet. Plunge pools at culvert outlets will capture sediment from ditch and road and prevent it from entering the lake. New/correct gravel surface material and crown needed.

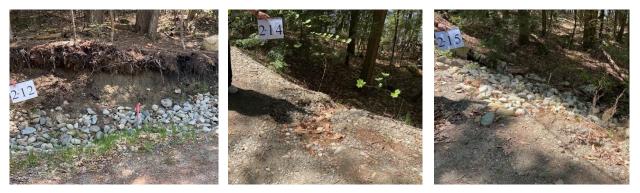
Problems: Ditch bank failure erosion, undersized and clogged cross culvert, unstable culvert inlet/outlet, unstable road shoulders, and road surface erosion.

Private road sites 2-12, 2-14, and 2-15 documented on Holman Terrace in Sector 2.

<u>Recommendations:</u> Improve ditch and stabilize bank slopes with rock and erosion control mulch, clean out or replace undersized/clogged culvert, and vegetate road shoulders to stabilize. Plunge pools at culvert outlets will capture sediment from the ditch and prevent it from entering the lake. New/correct gravel surface material and crown needed.

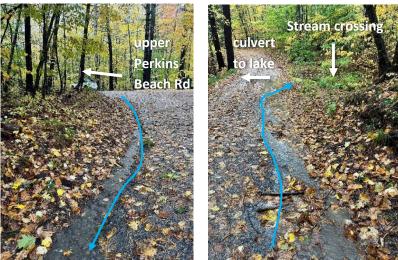
<u>Site Number(s):</u> 3-12, 3-12 b, and 3-15 (3 sites total) <u>Road type:</u> Gravel (private road) <u>Problems:</u> Road runoff flowing directly into stream or lake. <u>Recommendations:</u> In-road diversions (for example, broad-based dips) are needed to break up runoff flow on the upper portion of Perkins Beach Road. This will significantly reduce the amount of runoff making it to the bottom of the hill that is currently entering the stream culvert/the lake.

High-impact site 3-15 on Perkins Beach Road in Sector 3.

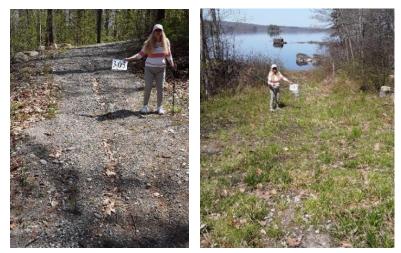
<u>Problems:</u> Gully erosion on road surface (3-05) because runoff is not able to flow off of roadway. Stormwater flows downhill and into lake via a residential access (3-04).

Site 3-05 (left) and site 3-04 (right) identified on Moose Run Road in Sector 3.

<u>Recommendations:</u> Build up road with new/correct surface gravel and install an in-road runoff diversion to move stormwater off the road surface and prevent erosion as it flows downhill.

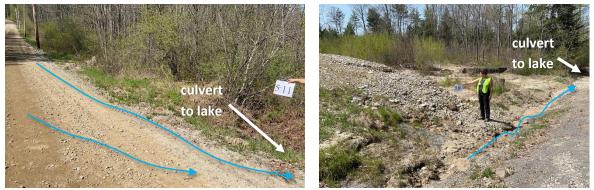
<u>Problems:</u> Poor surface gravel is easily erodible and transported. Significant plow/grader berms on road shoulders are preventing runoff from quickly exiting road surfaces and draining to surrounding woodlands. Evidence that runoff travels on road surface and shoulders for long distances, eroding the gravel and entering the lake indirectly via several stream culvert crossings.

Site 5-11 (left) and site 5-09 (right) identified on Bishop Hill and Bernie Hartford Roads in Sector 5.

<u>Recommendations</u>: Remove plow/grader berms, resurface with new/correct gravel surface material, and stabilize road shoulders. Formal ditches and ditch turnouts are needed in select locations to prevent drainage from roads and ditches from entering streams and flowing to lake.

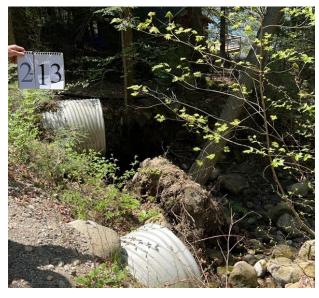
Bank failure at a culvert outlet (site 2-13) on Holman Terrace in Sector 2.

Site Number(s): 2-13 <u>Road type:</u> Gravel (private road) <u>Problems:</u> Double-barrel culverts are undersized. Bank failure on downstream side slopes (tree root system has broken away from bank and fallen into streambed below) and banks of stream channel are severely undercut between crossing outlet and the lake. <u>Recommendations:</u> This site will likely require significant technical assistance and an engineered design.

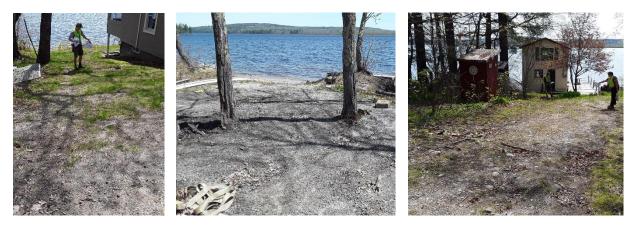
Example sites identified on Lakeshore Drive in Sector 7: Site 7-20 (left) medium-impact residential, site 7-28 (middle) high-impact beach access erosion, and site 7-15 (right) high-impact driveway erosion.

<u>Most Common Problems:</u> Surface erosion, bare soil, lack of or inadequate shoreline vegetation, shoreline erosion, runoff entering lake via boat launch or beach access.

<u>Recommendations</u>: Cover bare soil with Erosion control mulch or re-vegetate, establish or improve shoreline vegetation, install runoff diverters, install rain gardens.

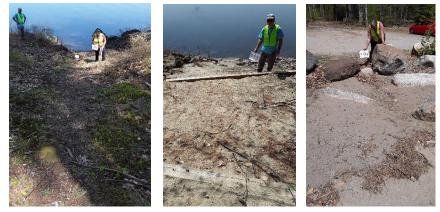
Most Common Problems: Surface erosion, bare soil, lack of or inadequate shoreline vegetation, undefined and unstable pathways.

Example sites identified in the Stinchfield Beach neighborhood in Sector 7: Site 7-06 (left) erosion on a shorefront pathway, site 7-11 (middle) unstable soils on a steep slope, and site 7-09 (right) runoff from a town parking lot is creating a channel with flow to Androscoggin Lake.

<u>Recommendations:</u> Cover bare soil with erosion control mulch or re-vegetate, establish or improve shoreline vegetation, define and stabilize pathways, install runoff diverters.

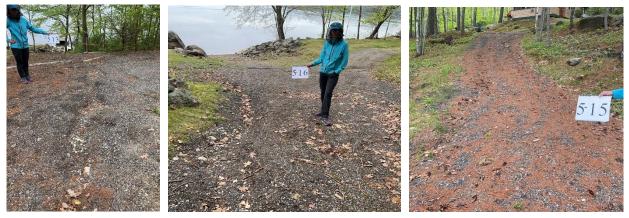
<u>Most Common Problems</u>: Shorefront path, dock access, and boat launch areas are experiencing erosion and convey stormwater runoff directly into the lake. Few low-lying places where runoff can be collected and infiltrated away from the lake exist. Lack of shoreline vegetation.

Example sites documented in the Angell Cove neighborhood in Sector 5: Site 5-13 (path/trail), site 5-16 (boat access), and site 5-15 (private road).

<u>Recommendations:</u> Install runoff diverters across water access points to prevent runoff from entering the lake. If needed, create places where runoff can be collected and infiltrated; for example, by installing a rain garden or creating infiltration steps at the dock access near the end of the road. Establish or improve the natural stand of vegetation existing on the shoreline.

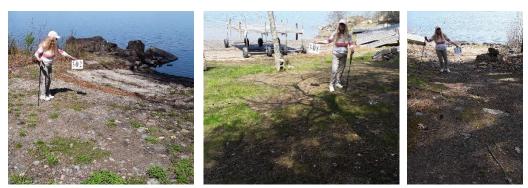
Most Common Problems: Bare soil, lack of or inadequate shoreline vegetation, runoff entering lake via boat or beach access.

Examples of sites identified in Sector 3: Site 3-02 (left) erosion on a beach access, site 3-08 (middle) bare soils and sheet erosion over a lawn without a shoreline buffer, and site 3-13 (right) erosion documented ono a shorefront path.

<u>Recommendations</u>: Cover bare soil with Erosion control mulch or revegetate, do not rake needles or duff, establish or improve shoreline vegetation, install runoff diverters across boat and beach access to prevent runoff from entering lake untreated.

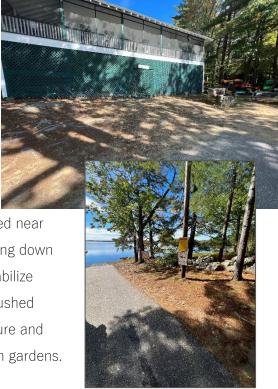
Erosion at roof driplines and adjacent common spaces (top) and boat launch (bottom) documented at site 9-14 in Wayne

<u>Recommendations:</u> Stormwater runoff diversions needed near parking lot and Lake Street to prevent runoff from flowing down boat launch and into the lake untreated. Define and stabilize common areas with erosion control mulch (ECM) or crushed stone, and add vegetation around edge to define, Capture and infiltrate roof runoff by installing a dripline trench or rain gardens. Improve stand of vegetation between developed spaces and the beach/lake.
