**ANDROSCOGGIN LAKE WATERSHED SURVEY
TOWNS OF WAYNE AND LEEDS**

Prepared for:
TOWN OF WAYNE

Prepared by:
SUMMIT ENVIRONMENTAL CONSULTANTS, INC.
640 Main Street
Lewiston, Maine 04240

December 11, 2000
Project 3309:1112.DOC

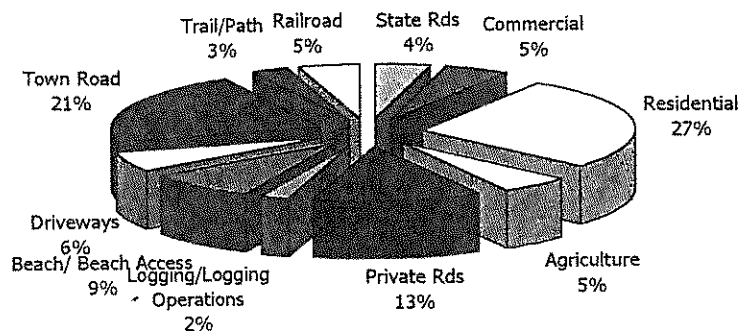
Percentage of Site by Land Use

Residential sites account for 27% of the identified erosion sites. State and town roads combined comprise 25% of the sites, private roads account for 13%, driveways account for 6%. Beach and beach access sites were combined to account for 9% of the identified sites, followed by agricultural sites (5%), commercial and logging operations, 5% and 2%, respectively, railroad sites (5%) and trail/path sites account for 3% of the surveyed sites. The following chart illustrates the land use breakdown.

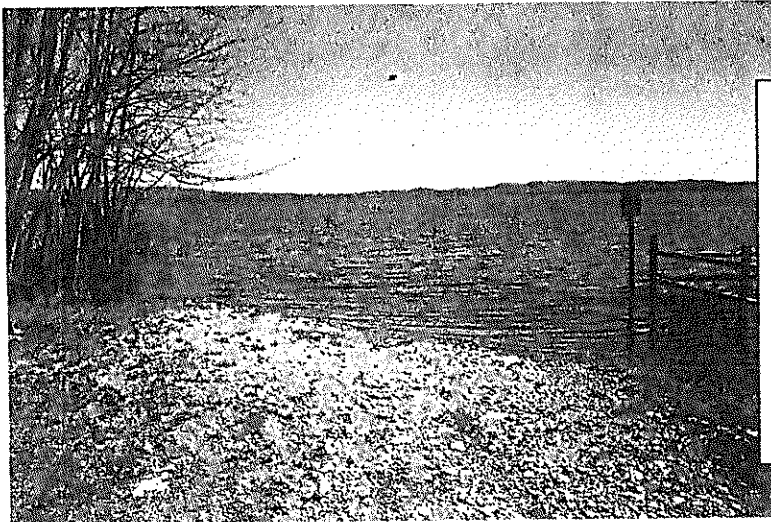
- Driveway ends at Lake shoreline.
- Bare soil
- Sediment transport direct to lake.

- Establish vegetative buffer.
- Use coarser less erodable surface materials for driveway.
- Install turnouts; open top culvert or water bars to direct runoff to vegetated buffers where runoff can be treated.

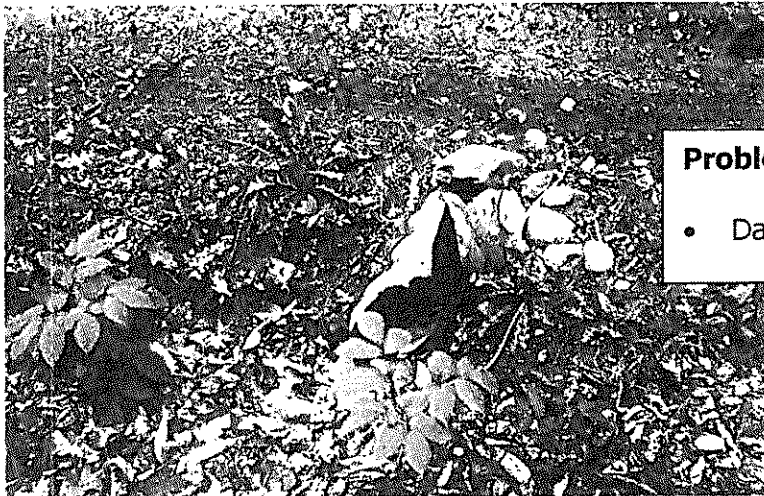
- Damaged Culvert.

- Replace or repair culvert.

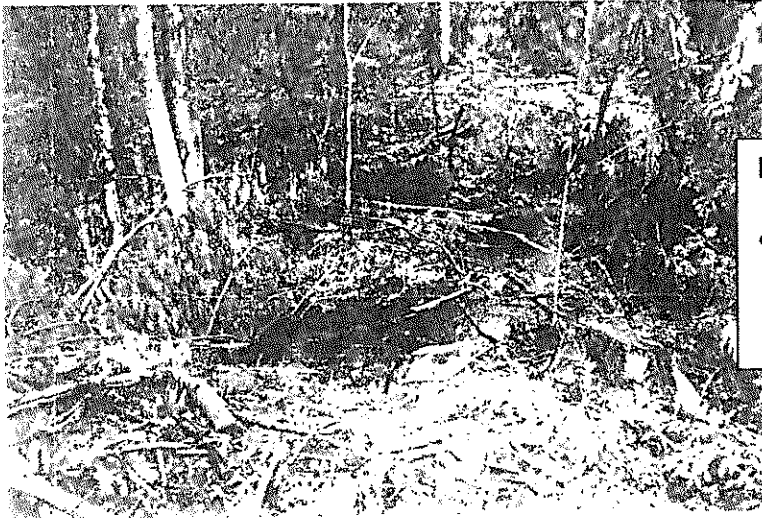
- Logging debris in ditch with runoff to Lake.

- Remove debris.
- Install silt fence and temporary culvert at access point.
