**POCASSET LAKE AND PICKEREL POND  
WATERSHED SURVEY**

**POCASSET LAKE ASSOCIATION**  
Wayne, Maine 04282

**SUMMIT ENVIRONMENTAL CONSULTANTS, INC.**  
640 Main Street  
Lewiston, Maine 04240

March 4, 2003  
Project 3520

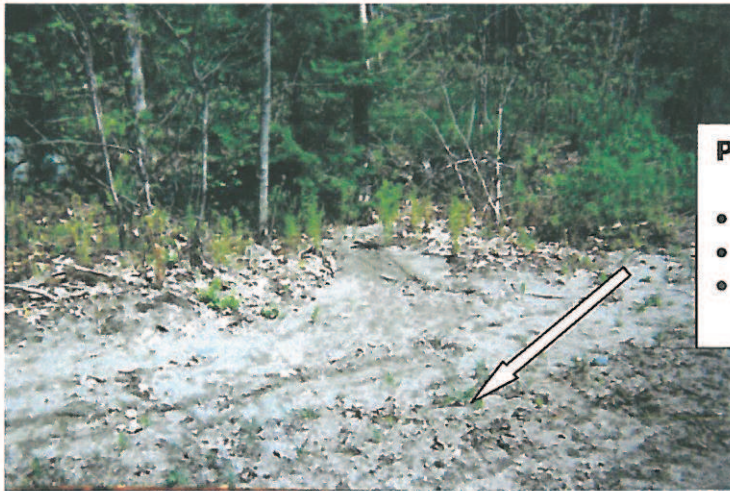
<b>Common Problems Identified:</b>	<b>Recommended Solutions:</b>
<ul style="list-style-type: none"> <li>• Slight to severe shoulder erosion</li> <li>• Surface erosion; sparse vegetation</li> <li>• Slight ditch erosion</li> <li>• Damaged and/or clogged culvert</li> <li>• Unstable culvert inlet/outlet</li> <li>• Poor road shaping</li> <li>• Stockpiled soils</li> </ul>	<ul style="list-style-type: none"> <li>• Stabilize with fill, rip rap and vegetate</li> <li>• Enhance vegetation along roadway</li> <li>• Stabilize ditch with riprap or vegetate</li> <li>• Replace and/or clean culvert</li> <li>• Rip rap around culvert inlet/outlet</li> <li>• Reshape road</li> <li>• Install silt fence or vegetate berm</li> </ul>

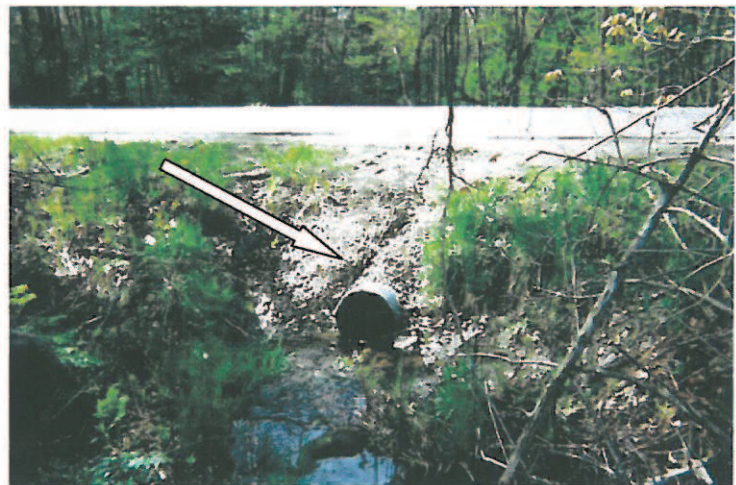
**Problems:**

- Ditch and shoulder erosion.
- Removal of winter sand.
- Unstable culvert.

**Solution:**

- Reshape eroded shoulders and vegetate.
- Stabilize ditches with vegetation, erosion control matting, or stone.
- Stabilize culvert inlet and outlet with riprap.

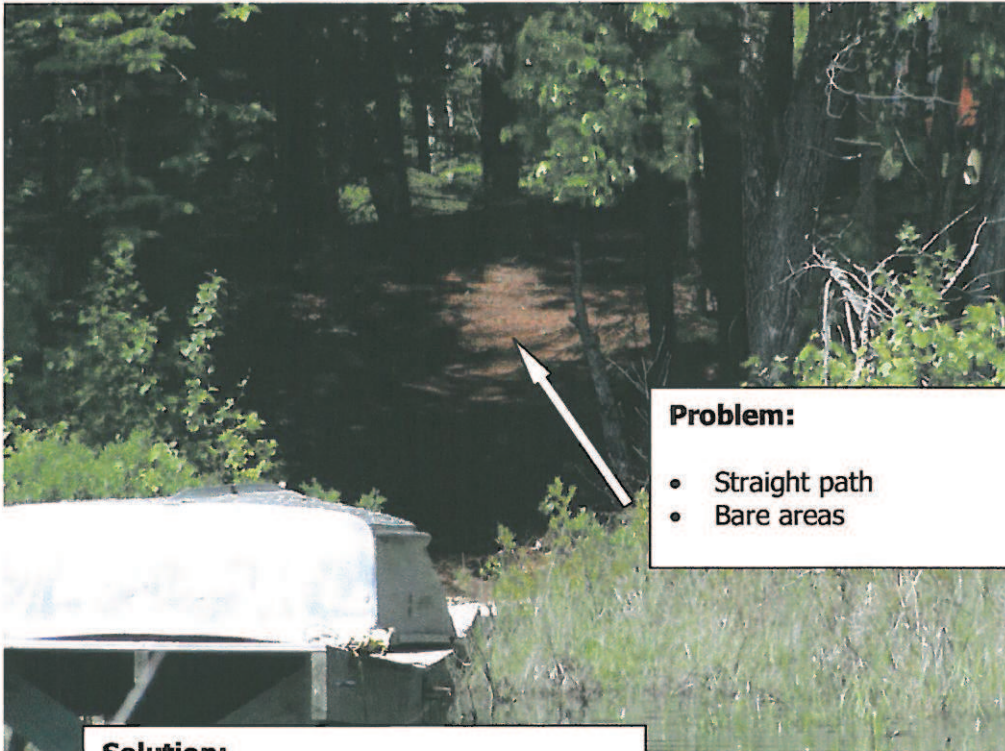
**Problem:**

- Straight path
- Bare areas

**Solution:**

- Establish meandering stone/gravel pathway
- Vegetate bare areas
